Marine Life Protection Act Initiative

Draft SAT Evaluation of Water and Sediment Quality at Palos Verdes Shelf

Presentation to the MLPA Master Plan Science Advisory Team

June 18, 2009 • Los Angeles

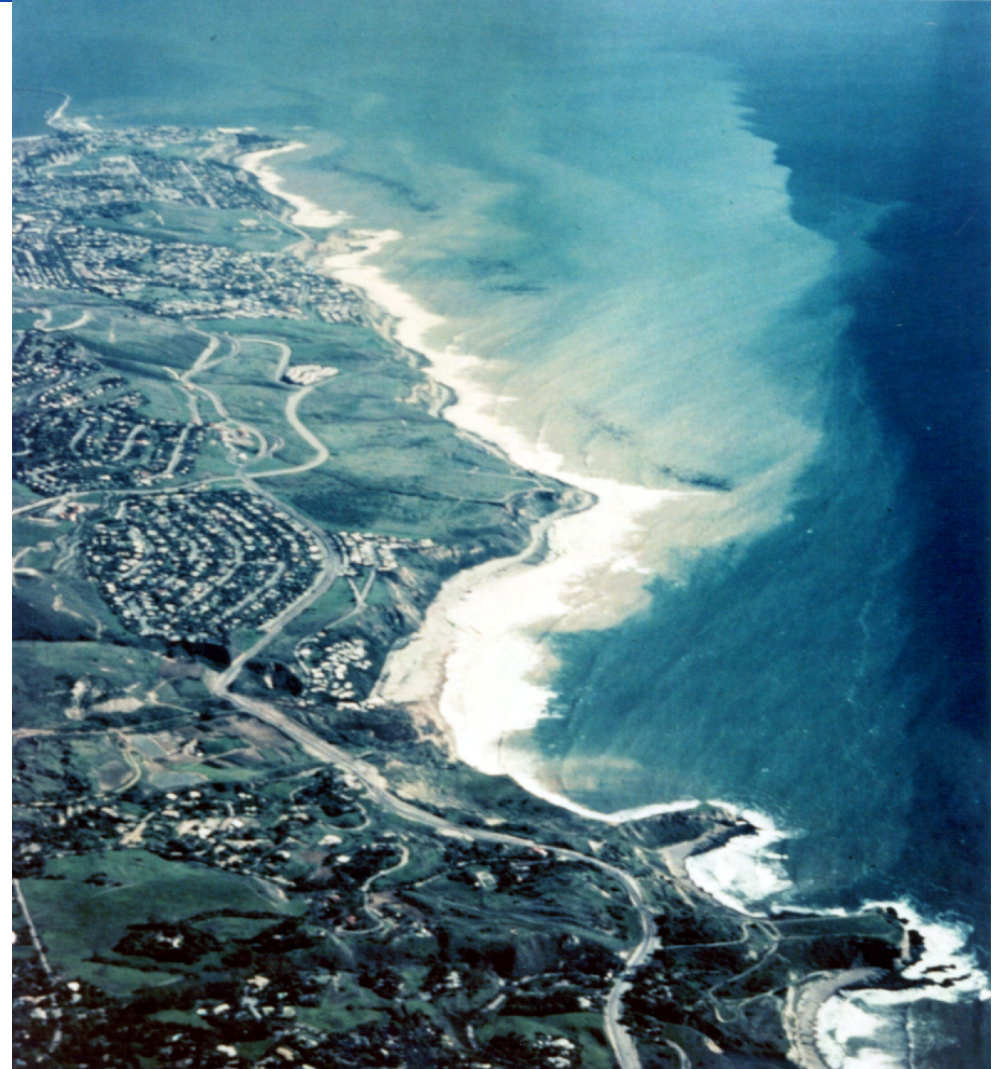
- Portuguese Bend landslide occupies a 1.06 km² portion of the PV Peninsula
- Sediment plume has been visible since 1956
- Plume extends mostly from Portuguese Point to White Point although sometimes it runs north to Long Point

Photo taken sometime in the 1980s

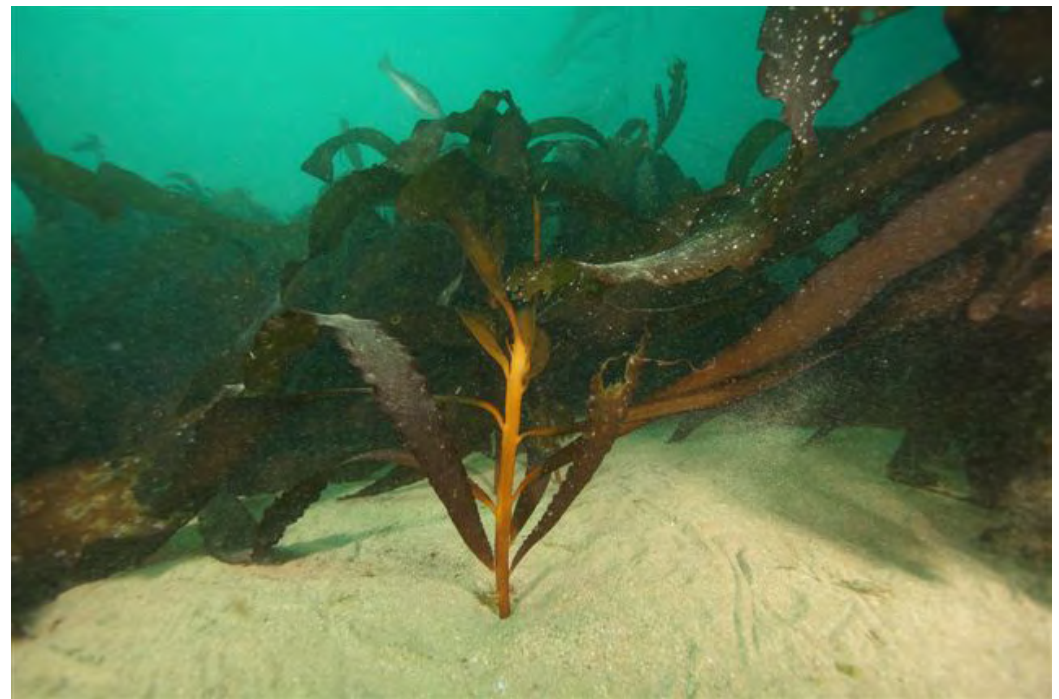
- Sedimentation/turbidity:
 - Ø Buries reefs
 - Ø Reduces kelp recruitment
 - Ø Has created large scale changes in macrophyte composition
 - Ø Has reduced habitat value (based on fish assemblage)

Example of buried reef at Bunker Point,
October 22, 2008
